# Analysis of The Causes of Crankshaft Failure In The Komatsu Egs 1200 Diesel Engine at Pt. Pltd Bengkalis

Hardi<sup>1\*</sup>, Ibnu Hajar<sup>2</sup>

<sup>1,2</sup>Program Studi Sarjana Terapan Teknik Mesin Produksi dan Perawatan,  
Politeknik Negri Bengkalis, Riau 28714, Indonesia.

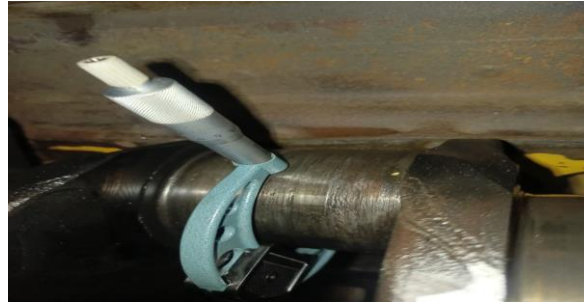
**Fig. 1. Crank Pin Measurement Process**

The measurement results indicate that crank pins No. 1, 2, 3, and 6 still have a diameter of 100.00 mm, which is in accordance with the manufacturer's standard specifications and remains within the allowable tolerance limits. In contrast, crank pins No. 4 and 5 experienced wear with measured diameters ranging from 99.40–99.55 mm, exceeding the allowable tolerance limit and no longer meeting the operational requirements. This condition indicates the occurrence of wear on the crank pin surface, which can increase the clearance between the crank pin and bearing. The increased clearance may lead to a reduction in lubricating oil pressure, higher mechanical vibration, increased bearing operating temperature, and accelerated bearing deterioration.

Based on the Failure Mode and Effects Analysis (FMEA) results, this failure mode is likely caused by several factors, including inadequate lubrication, oil contamination, excessive operating loads, and component misalignment. Therefore, this failure mode is categorized as a high-risk condition and requires corrective actions, such as component inspection, maintenance improvement, and periodic monitoring, to prevent further damage to the crankshaft system and maintain the reliability of the Komatsu EGS 1200 diesel engine.
