# Implementation of The Plan Maintenance System (PMS) Function on Lifeboats to Support Sailing Safety on The Jambo VIII Ferry Motor Ship

*Sailing safety on passenger ships such as KMP Jambo VIII is often threatened by lifeboat failure due to suboptimal maintenance, even though the Plan Maintenance System (PMS) has been implemented. This study aims to analyze the implementation of the PMS function on lifeboats and identify its obstacles to supporting sailing safety. This type of qualitative descriptive research was conducted on the KMP Jambo VIII crew population with a purposive sample of 4 key informants (Captain, Chief Officer, Pumpman, Boatswain). The main research instruments were supported by semi-structured interview guidelines, observation sheets, and documentation; data analysis used the Miles and Huberman model (reduction, presentation, conclusion). The results show that the PMS runs through tiered inspections despite being hampered by a busy operational schedule, scarcity of spare parts, and administrative-field gaps. The conclusion recommends regular crew training and PMS digitalization for safety optimization.*

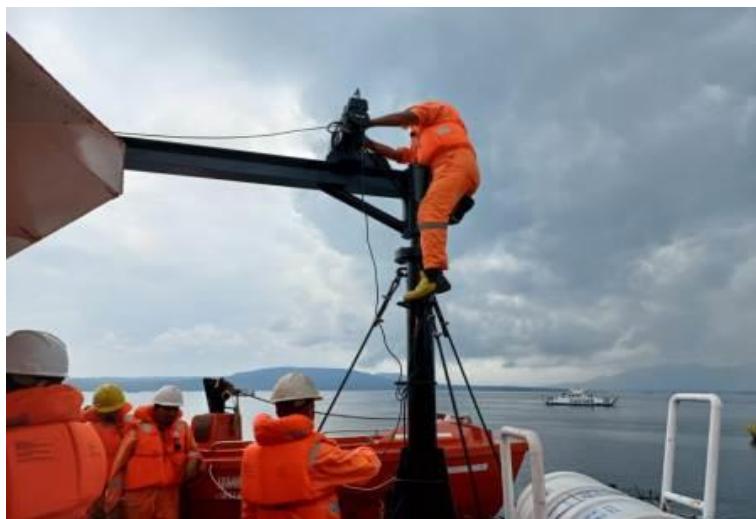
**Fig 2.** Inspection of Lifeboats on KMP Jambo VIII

The document is part of the Plan Maintenance System (PMS) which contains a report on routine inspections of the rescue boat on KMP. JAMBO VIII for the period of September 2024. The inspection was carried out at two locations, namely at the wind deck position and the twin deck position, focusing on important components such as wires, cranes, crane operations, dynamo engines and ront crates, batteries, rescue boat conditions, and rescue boat lifting ropes/wires. Each item checked through maintenance activities includes; visual inspection, greasing, crane movement function testing, battery checking, to ensuring the physical condition and completeness of the rescue boat remains good.

The inspection results are recorded in the condition column and the results show that all items are declared good, indicating that the rescue boat is in a ready-to-operate condition according to PMS safety and maintenance standards. The inspection is signed by the implementing party and approved by the Third Officer as a form of control and verification of periodic maintenance. In this case, the researcher focuses on discussing the process of implementing the Plan Maintenance System function on the lifeboat on the KMP. Jambo VIII ship. From the research, the researcher found that there were several lifeboat maintenance procedures that were rarely carried out in accordance with the SOP contained in SOLAS Chapter III Regulation 20, such as the infrequent maintenance of lifeboats due to the tight loading and unloading schedule so that they did not carry out procedures in accordance with the existing SOP. After conducting observations, the researcher obtained and collected data to be used as research material. The data and observation results obtained by the researcher are attached as follows:

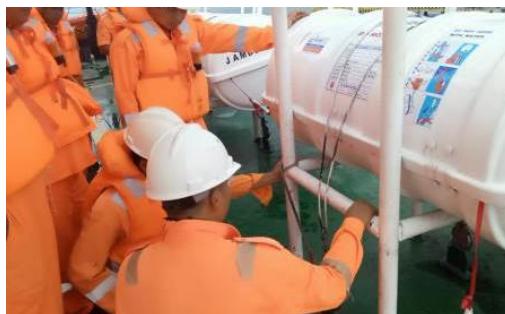
**Fig 3.** Checking the Lifeboat

Documentation is an important instrument in qualitative research to provide concrete evidence regarding the condition of the research object and to support the results of observations and interviews. In the context of this research, documentation was conducted during the researcher's twelve-month Sea Practice (PRALA) on KMP Jambo VIII. Documentation includes photographing, recording the ship's technical documents, a Plan Maintenance System (PMS) checklist, and recording visual data related to lifeboat maintenance activities. The documentation provides a concrete picture of how the PMS is implemented administratively and operationally in the field. In general, documentation indicates that the lifeboats on the KMP. Jambo VIII are in fairly good operational condition. The photographs obtained show the physical condition of the lifeboats, including their hull structure, paintwork, the position of the safety ropes (gripes), the condition of the davits, winches, engines, and the completeness of the survival equipment on board. However, the documentation also reveals a number of findings indicating the need for improved maintenance. For example, the exterior paint on the lifeboats appears to be fading due to exposure to extreme sea conditions; several drain plugs appear difficult to open and require lubrication; and the propellers are occasionally blocked by debris and require more regular cleaning.

Research observations found that several components, such as the davits, drain plugs, lifeboat paint, and propellers, did not always receive thorough maintenance due to time constraints resulting from tight loading and unloading schedules. Interviews with crew confirmed that maintenance often stalled when operational activity increased, resulting in some procedures being carried out quickly and indefinitely. Furthermore, crew turnover caused differences in the ability to understand the PMS SOP, resulting in unequal inspection quality between periods. While the PMS checklist documentation did indicate that all components were in "good" condition, technical triangulation revealed a lack of synchronization between administrative reports and field conditions, indicating that the records sometimes did not fully reflect the technical reality. Furthermore, limited availability of spare parts on board meant that comprehensive repairs could only be undertaken during docking. Therefore, it can be concluded that the obstacles to the implementation of the PMS on KMP. Jambo VIII were closely related to the ship's operational dynamics, crew competency, and the availability of supporting facilities, which collectively hampered the effectiveness of lifeboat maintenance.
