Efforts to Prevent Oil Spills in Accordance with Annex I Implementation on the MT Capella Ship

I Komang Gede Dimas Saputra^{1*}, Sutoyo², Wulan Marlia Sandi³, Upik Widyaningsih⁴

^{1,2,3,4}Ship Operational Engineering Technology Study Program, Politeknik Pelayaran Surabaya, Indonesia

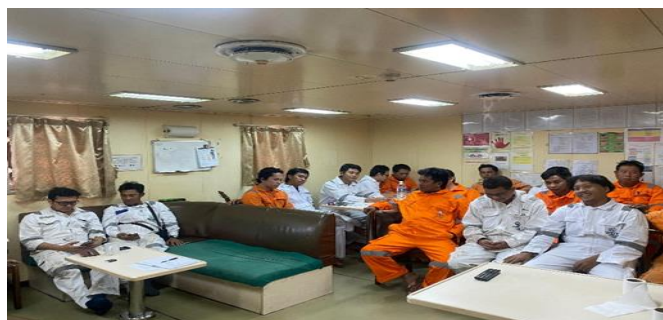
Fig. 1. Tool box meeting activity

On Thursday, January 2, 2025, at 09:00 LT (GMT+8), before the cargo operation began, all deck crew members attended a toolbox meeting led by the Chief Officer in the main deck area. The meeting discussed the work plan, cargo type, loading and unloading sequence, estimated pump pressure and flow rate, and the division of supervisory duties in the manifold area, tank sounding, communication with the terminal, and standby in the pump room. In addition, potential hazards such as leaks in the manifold, gasket damage, overpressure, tank overfilling, and the risk of slippery decks due to oil spills were identified. Researchers' observations indicate that this activity serves as an initial preparedness step in preventing oil pollution.

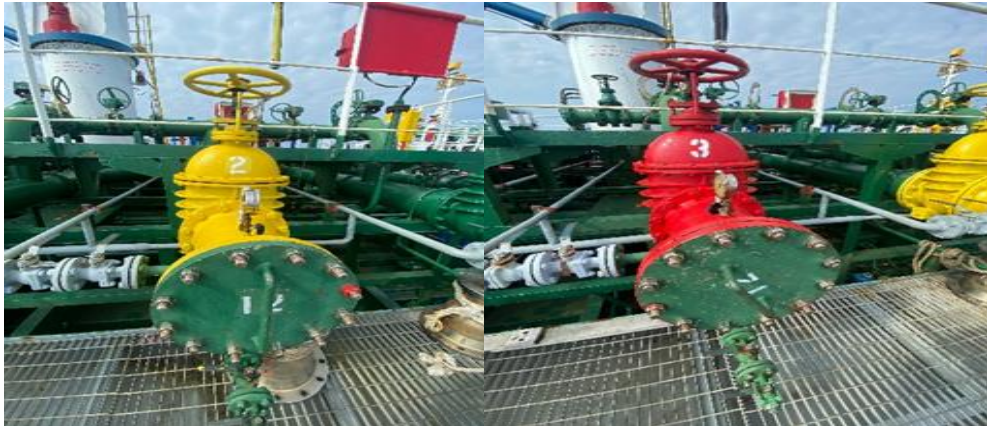
Fig. 2 Manifolds 2 and 3

Furthermore, on the same day, Thursday, January 2, 2025, at 1:00 PM LT (GMT +8), the research documented the physical condition of the cargo manifold area while the ship was sailing from Advario Port, Singapore to Bintulu Port, Malaysia. The observation results showed that the manifold is the central point of the cargo piping system that works under certain operational pressures. At the reducer connection, the use of flanges and gaskets as sealing elements is visible to maintain the forward flow of the system. In general, the visual condition looks normal, and a drip tray has been installed under the manifold connection as a preventive measure in case of oil seepage.

At 13:00 LT while sailing to Bintulu, Malaysia, visual observation showed normal manifold with drip tray installed on the flange to catch seepage; reducer/gasket as a critical point under operational pressure appeared to be sound but potentially worn without regular replacement, indicating the need for optimal preventive maintenance even though there were no active leaks.

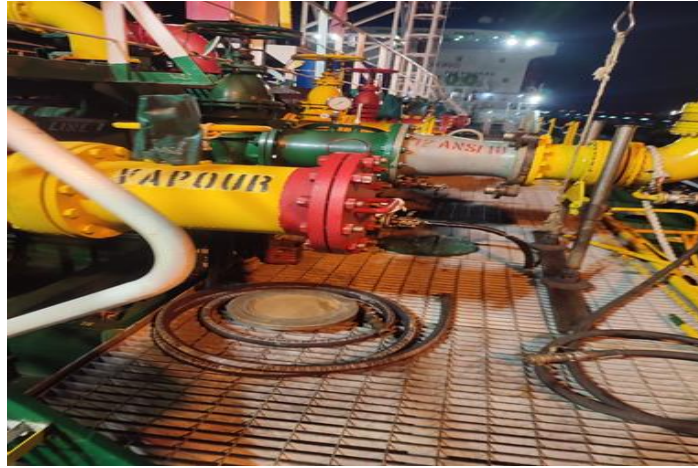
Fig. 3. Cargo operation

On Monday, February 17, 2025, at 10:00 PM LT (GMT+8), during cargo operations and the cargo pumps operating at operating pressure, researchers observed oil seepage at the reducer flange connection. The seepage was classified as minor leaking and was collected in the provided drip tray. Visually, the gasket at the connection appeared to have worn out, characterized by hardening and loss of elasticity. This condition causes a decrease in sealing capacity when the system is under operating pressure.

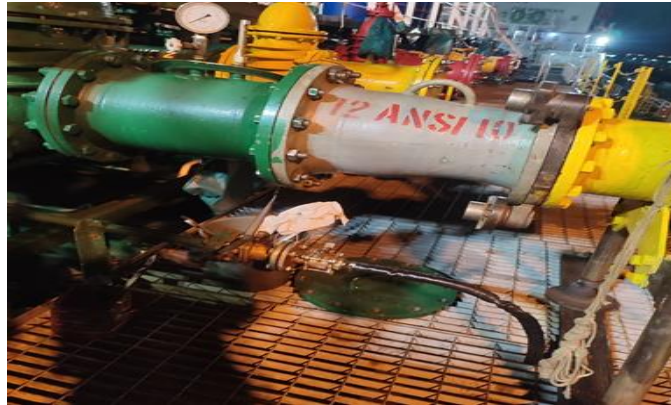
Fig. 4. Indications of a leak

At 3:00 PM LT on the same day, researchers conducted further observations of the leak's impact. They observed a thin layer of oil around the flange, causing the deck surface to become slippery and potentially posing a slip hazard to the crew. However, no marine pollution occurred as the leaking oil was properly contained and promptly handled by the crew on duty.

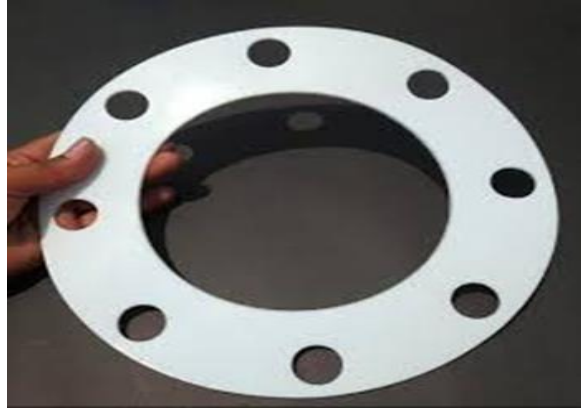
Fig. 6. Gasket

On January 2, 2025, at 1:00 PM LT (GMT+8), the vessel sailed from Advario Port, Singapore to Bintulu Port, Malaysia. Researchers documented the boatswain gasket at the reducer connection of the cargo pump manifold—a sealing component that maintains the tightness of the cargo pipe at different diameter flanges. The reducer adjusts the pipe size under operational pressure and pump vibration; the gasket works via compression (filling micro-gaps when bolts are tightened to the appropriate torque), and is made of oil-resistant material that can withstand pressure and temperature. Critical condition: Wear, deformation, cracking, or loss of elasticity (due to age/stress) lead to potential leaks and oil spills. Therefore, the gasket requires regular inspection and preventive maintenance.

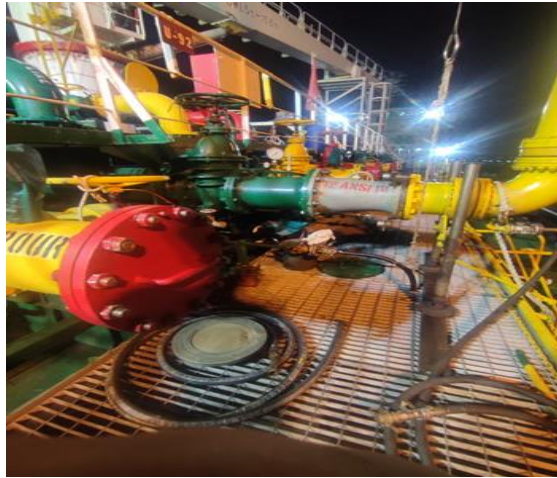
Fig. 1. Cargo operation activities in the manifold area

On February 17, 2025, at 10:00 PM LT (GMT+8), during cargo operations at MT. Capella, investigators observed minor leaks at the manifold reducer flange connection; the leak was contained in a drip tray, preventing it from polluting the sea. Visual inspection revealed that the gaskets had decreased elasticity and hardened due to operational stress and age, indicating wear and tear that reduced sealing performance.
