Implementation of the Use of Sopep Equipment During Bunkering on the MT Giat Armada 04 Ship

^{1,2,3,4}Diploma IV Program in Maritime Affairs, Surabaya Maritime Polytechnic, Indonesia

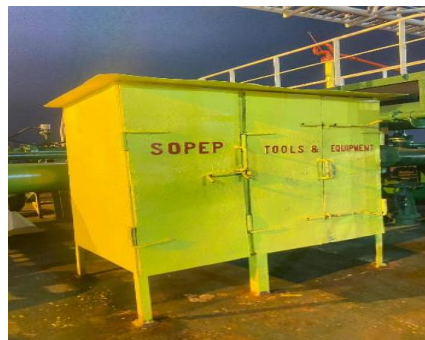
Fig. 2. SOPEP Equipment Box
Source: Personal documentation (2025)

The SOPEP box on the MT GIAT ARMADA 04 ship is located to the right of the cargo pipe near the loading and unloading manifold and fuel bunker above COT 5 S. The placement of this SOPEP box also makes it easier for the ship's crew to prepare SOPEP equipment during bunkering or loading and unloading. The SOPEP box contains a list of equipment determined by the company regarding the contents and quantity in the SOPEP box. The list of SOPEP equipment on the MT GIAT ARMADA 04 ship is as follows.

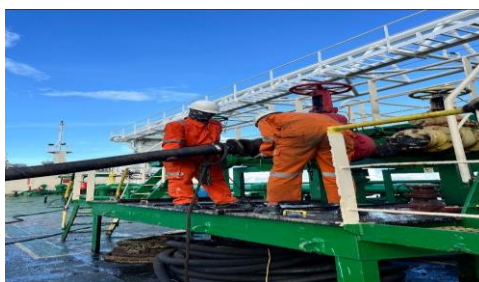
On Monday, May 12, 2025, in the Anchor area of Makassar port MT GIAT ARMADA 04 carried out a ship to ship bunkering process with SPOB Bima 01. In this process, everything has been prepared according to the bunker procedures set by the company. At 09.24 preparation for the bunker process test when the oil began to transfer, a leak occurred in the manifold of the MT GIAT ARMADA 04 ship, the fastening of the flange by the bolt was not tight and precise enough, resulting in this. Because of this incident, oil spilled under the manifold so that the bunker process had to be stopped first. The oil spill was immediately cleaned using SOPEP equipment according to the procedure, the researcher also documented this incident which the researcher included in the form of images in the attachment. In this incident, the researcher examined how the crew implemented the use of SOPEP equipment during bunkering. The researcher also conducted interviews and gave questionnaires to the ship's crew to obtain valid data regarding the implementation of the use of SOPEP equipment during bunkering.

Fig. 4. Bunker hose flange leak
Source: Researcher Documentation (2025)
