Maintenance of the Lifeboat on Board the MV Jambo X

^{1,2,3,4}Surabaya Maritime Polytechnic Applied Undergraduate Study Program
Ship Operation Engineering Technology, Indonesia

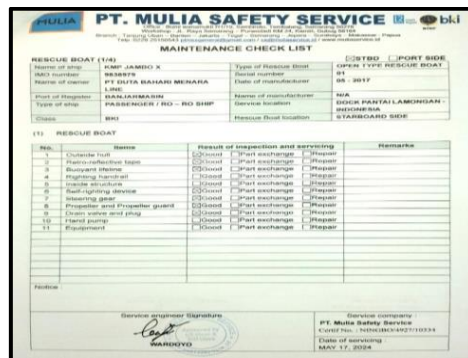
Fig. 3. Body Maintenance Check List

Figure 3 shows that the main components are stated to be in good condition and do not require replacement or repair of supporting equipment aspects, including hand pumps and other equipment, the inspection results also show good condition with no record of the need for repair or replacement of spare parts. There is no information about damage or non-conformity listed in the remarks column, which indicates that all items inspected have met inspection standards.

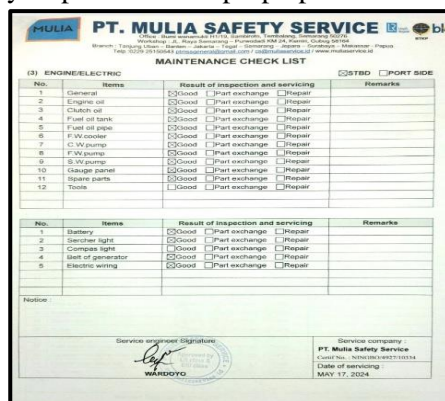
Fig. 4. Engine Maintenance Check List

The engine system inspection results showed that the engine was in good general condition, with the volume and quality of engine oil and clutch oil still meeting operational standards. The fuel oil tank and fuel oil pipe showed no leaks or damage, thus deemed safe for use, while the cooling system—consisting of a fresh water cooler, cooling water pump, fresh water pump, and sea water pump—functioned normally without any indication of problems. In the electrical system, the battery was in good condition and ready to use, as were the search light, generator belt, and electrical cables operating normally without damage or wear, and navigation lights such as the compass light were declared to be functioning properly. Overall, no items were found that required repair or component replacement (part exchange).
