Analysis of Crew Readiness for Anchoring on the KMP Trisna Dwitya

Keywords: Ship's Crew, Procedures, Anchoring Maneuvers, KMP. Trisna Dwitya and Fishbone Analysis.

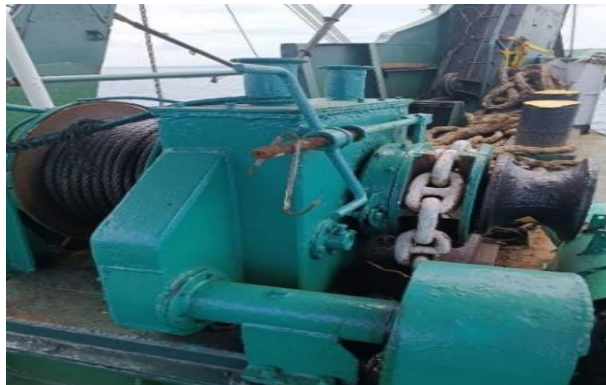
Fig 1. Windlass

To support the results of this research, the researcher presents documentation in the form of a windlass, namely a tool that. Its function is to mechanically raise and lower the anchor, and to help hold the ship when anchored by controlling the anchor chain so that the ship does not move due to currents, wind or waves.

Based on documentation obtained during the anchoring maneuver, it was apparent that the windlass was not functioning optimally at the start of the operation. At the first moment of lowering the anchor, a jam occurred, preventing the anchor chain from coming out smoothly. This indicated a disruption in the windlass' mechanical system, which impacted the smoothness of the initial anchoring process. This documentation reinforces the observation that greater attention is needed to ensure the condition and maintenance of the equipment for a safe and effective anchoring process.

During the anchoring maneuver, several obstacles directly affected the smoothness, effectiveness, and safety of the operation. The first obstacle encountered was the suboptimal condition of the windlass. During initial operation, the windlass movement was not smooth and tended to stutter. When the anchor was about to be lowered, the anchor chain came out unstably and even jammed. After further observation, it was discovered that the lack of routine maintenance was the main factor causing the problem, particularly in the lubrication system (greasing) of the gears, bearings, and drive shafts. The lack of lubrication caused

excessive friction on the mechanical components, resulting in harsh sounds, jerks at the start of rotation, and increased the risk of premature wear. This condition not only slowed the anchor lowering process but also potentially endangered the safety of the deck crew if there was a sudden increase in load on the anchor chain.

The Boatswain, acting directly at the bow, stated that during the anchoring maneuver, there were minor issues with the windlass at the start of operations. At the first moment of lowering the anchor, the windlass engine did not immediately operate smoothly and experienced a brief jam, requiring greater caution. The anchor chain did not come out smoothly as it should, requiring inspection and adjustment before operations could resume. According to the Bosun, this condition was likely caused by suboptimal maintenance and lubrication of the windlass' mechanical components. Although these issues were quickly resolved, the situation slowed down the process and required increased vigilance from the crew on duty at the bow.

anemometer and a suboptimal windlass at the start of the anchoring operation, which caused congestion. These conditions demonstrate the importance of routine maintenance and thorough inspections before the maneuver to maintain equipment reliability.

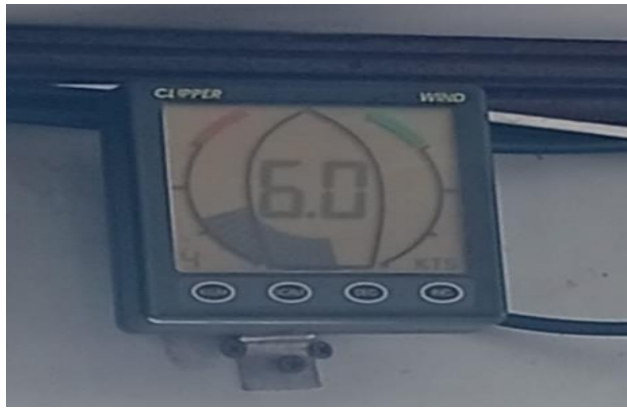
Fig. 2. Anemometer

Anemometers on ferry ships are crucial navigational tools installed to measure wind speed and direction in real-time.

Based on documentation during the anchoring maneuver, it was discovered that the anemometer on the ship's bridge was not functioning. This was evident from the lack of wind speed or direction data displayed on the indicator screen. This condition indicated that the instrument could not be used as a reference for monitoring wind conditions during the anchoring maneuver, resulting in an inadequate availability of weather information that would have supported decision-making.

The second obstacle was the malfunctioning anemometer on the ship's bridge. This instrument should provide real-time wind speed and direction information to assist the captain in determining approach strategies to the anchorage point. However, during observations, the anemometer did not provide accurate data, or even gave no readings at all. As a result, the officer on watch and the captain relied solely on visual observations of sea surface conditions and personal experience to estimate the effect of wind on the ship's motion. This lack of quantitative data increased uncertainty in drift calculations, making determining the ship's heading before dropping anchor less precise. In maneuvering conditions requiring high precision such as anchoring, inaccurate wind information could cause the ship to drift off course or require repeated engine corrections.

The second officer explained that during the anchoring maneuver in the Bali Strait, the anemometer on the bridge experienced problems, preventing it from accurately displaying wind speed and direction data due to sensor damage. This condition occurred when the ship was approaching the anchorage point in a situation with strong currents and changing seasonal winds. Nevertheless, the second officer stated that the ship's officers were still able to detect the direction and estimated wind strength based on sailing experience, by observing the direction of waves, ripples on the water surface, the waving of the flag, and the movement of the ship's chimney smoke.

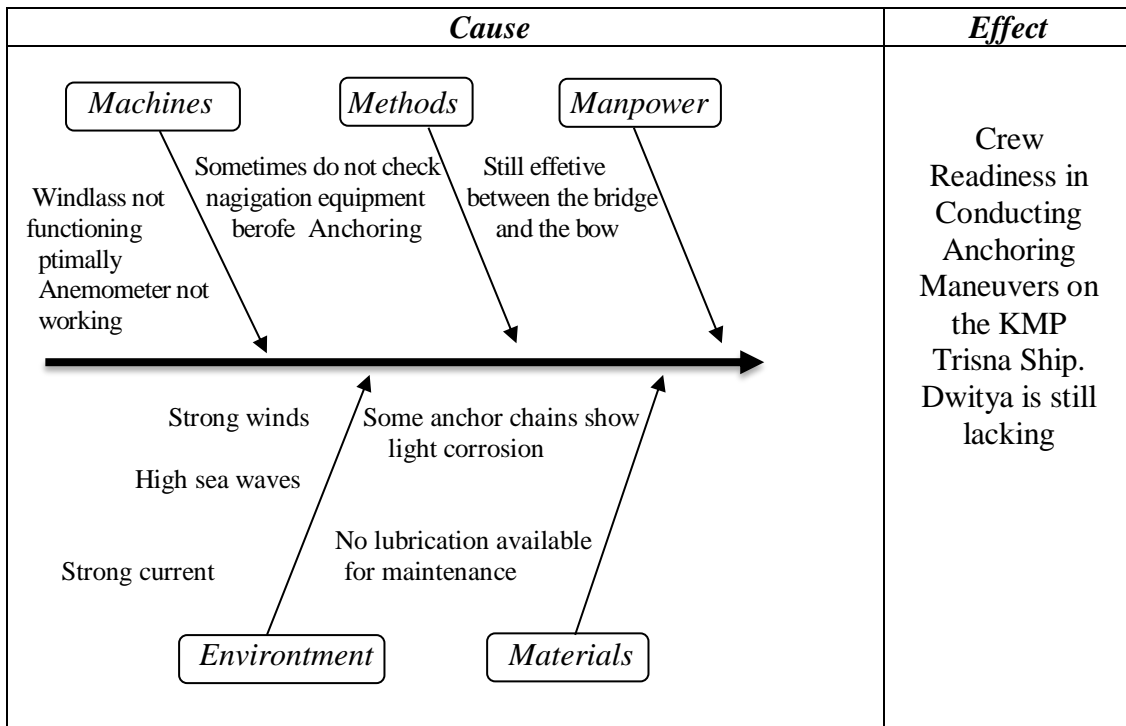
Fig 3. Fishbone Chart
Source: Processed Researcher Data (2025)

Based on the problem identification above, a detailed fishbone chart can be presented of several main factors causing the crew of the KMP Trisna Dwitya to be less prepared in carrying out anchoring maneuvers on the ship as follows:
