Analysis of The Use and Maintenance of Mooring Ropes To Support Safety When Ships Are Moored

^{1,2,3,4}Ship Operation Engineering Technology Study Program, Surabaya Maritime Polytechnic, Indonesia

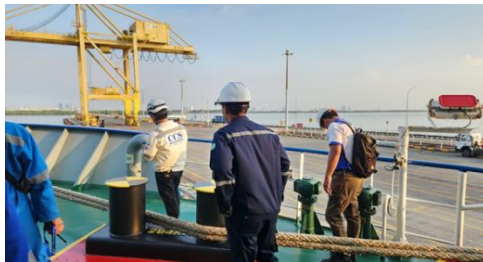
Fig 1. Surveyors from the China Classification Society conducted an inspection of the condition of the mooring lines.

On Monday, June 23, 2025, surveyors from the China Classification Society (CCS) conducted an inspection while the ship was docked at Tanjung Perak Port, Surabaya. The surveyors found the mooring lines on board were in good condition, with no signs of damage.

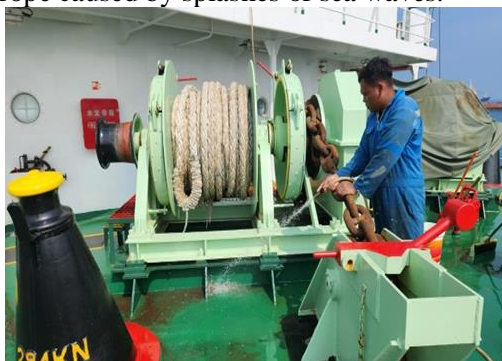
When the ship was on its way from Tangkiang to Surabaya, the Chief Officer ordered the bosun and deck crew to clean the forecastle deck including the winch engine, rope drum and also the mooring rope to avoid corrosion and wear on the rope caused by splashes of sea waves.

Picture 3 Deck Crew Cleaning
