Analysis of The Use And Maintenance of Lifeboats To Support Safety On Board The Mv. Tanto Subur II

Agung Nugroho^{1*}, Firdaus Sitepu², Damoyanto Purba³, Muhammad Dahri⁴

^{1,2,3,4}Surabaya Maritime Polytechnic Applied Undergraduate Study Program
Ship Operation Engineering Technology, Indonesia
Email : agungnu1001@gmail.com

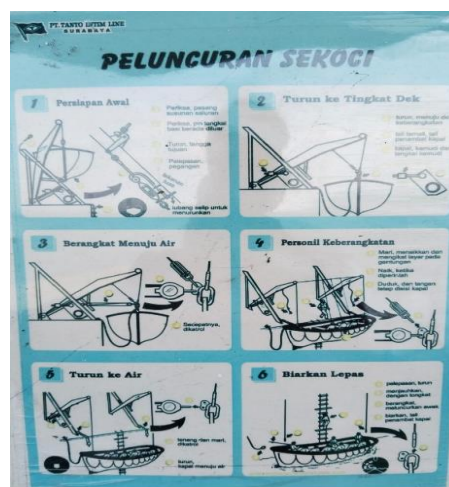
Fig. 1. Lifeboat Launching Procedure

One of the documents used as secondary data in this study is the Standard Operating Procedure (SOP) for launching an enclosed lifeboat. This SOP outlines the steps that must be taken by the crew during the process of lowering an enclosed lifeboat into the sea during an emergency. The procedure covers crew preparation, opening the enclosed lifeboat's lashing and stopper, operating the davit system, and lowering the enclosed lifeboat to the sea surface. This SOP aims to ensure that the enclosed lifeboat lowering process is carried out safely, in a coordinated manner, and in accordance with applicable safety regulations.

A good understanding of SOPs helps each crew member understand their duties, responsibilities, and the steps they must take correctly and orderly during the enclosed lifeboat launch process. Good coordination and communication will ensure a safe, orderly process that meets safety standards.

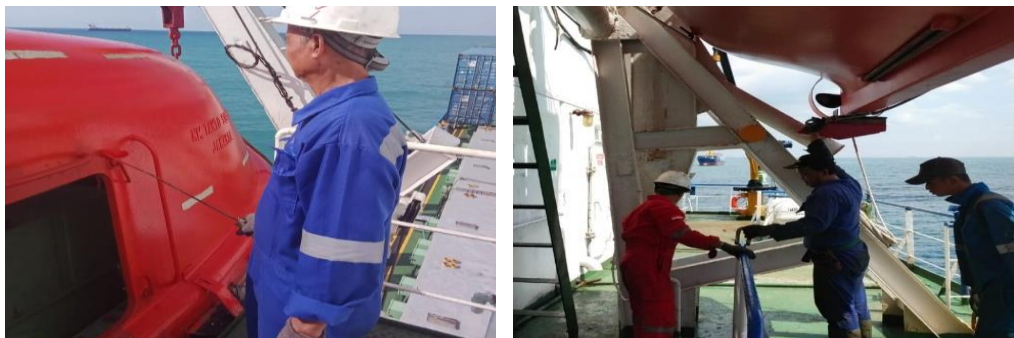
Fig. 2. Body Enclosed Lifeboat Maintenance and Wire Replacement

body on the left has begun to fade, the Third Officer carries out maintenance by repainting the enclosed lifeboat body with orange color and continued with marking up the identity of the enclosed lifeboat. The condition of the wire that is no longer suitable is immediately replaced by the Third Officer with a new wire. Checking the enclosed lifeboat engine, fuel, lubricating oil, cooling system, as well as periodic engine start-up tests, and checking the goddasses, wire rope, brake system, hook release gear to ensure the enclosed lifeboat can be lowered and operated safely and smoothly.

In addition, maintenance activities on the enclosed lifeboat body are also part of the secondary data supporting this research. *lifeboat* Periodic maintenance is carried out to maintain the physical condition of the enclosed lifeboat so that it remains in good condition. These maintenance activities include cleaning the enclosed lifeboat body, repainting certain parts that are damaged or corroded, and visually inspecting the enclosed lifeboat's structural condition. Maintenance is also carried out on the enclosed lifeboat wire by periodically applying grease (lubrication). Greasing the wire aims to prevent corrosion, reduce friction, and maintain the strength and flexibility of the wire so that it remains in optimal condition during use. If the wire is found to be worn or damaged, it is replaced according to the procedures in force on board the ship.

This maintenance includes cleaning, painting, body repairs with fiber and resin, and routine wire lubrication. On the MV Tanto Subur II, these activities have been carried out as scheduled to maintain the enclosed lifeboat's serviceable condition and prevent further damage.

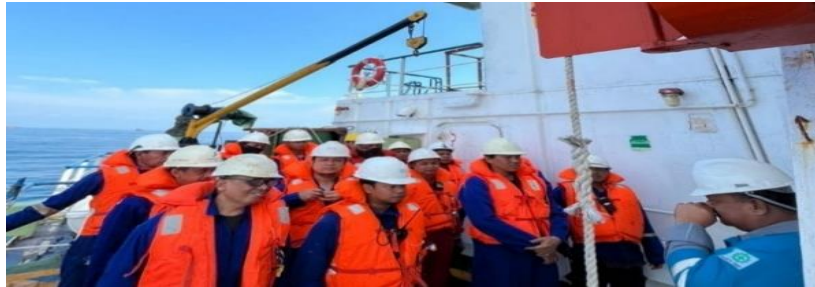
Fig. 4. Implementation of Lifeboat Drill

In addition to engine maintenance and testing, the MV. Tanto Subur II also conducted a lifeboat drill as part of safety training for the entire crew. This lifeboat drill aimed to improve the crew's preparedness in dealing with emergencies, particularly in the evacuation process using an enclosed lifeboat. During the lifeboat drill, the crew simulated the preparation for lowering the enclosed lifeboat and re-understood their respective duties and responsibilities according to the assigned division of tasks.
