# Identification of Mooring and Unmooring Risks to Minimize Workplace Accidents on the MV. CTP Honor Using the Hierarchy Method

Based on these conditions, this study aims to identify potential hazards, analyze the risk level of work accidents in mooring and unmooring activities using the HIRARC (Hazard Identification, Risk Assessment, and Risk Control) method, and determine risk control measures that can be applied to minimize work accidents on board the MV. CTP Honour. This study is important because the results of risk identification and assessment are expected to be the basis for preparing more effective risk controls to improve the work safety of ship crews. The novelty of this study lies in the application of the HIRARC method which is focused on hazard identification, risk assessment, and risk control in mooring and unmooring activities on board the MV. CTP Honour based on operational conditions directly observed during sea practice.

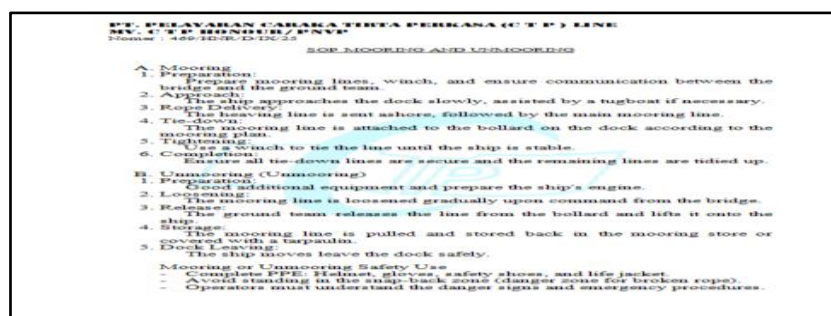
**Fig. 1. SOP for Mooring and Unmooring on the MV.CTP Honour Ship**  
**Source: Ship Documents (2025)**

The following is an SOP issued by the company PT. Caraka Tirta Perkasa which is intended for owned vessels, as follows:

In addition to the work steps, the *SOP* also outlines safety procedures for mooring and unmooring, including the use of complete PPE, including helmets, gloves, and safety shoes. Crew are also required to avoid snap-back zones and understand hazard signs and applicable emergency procedures.

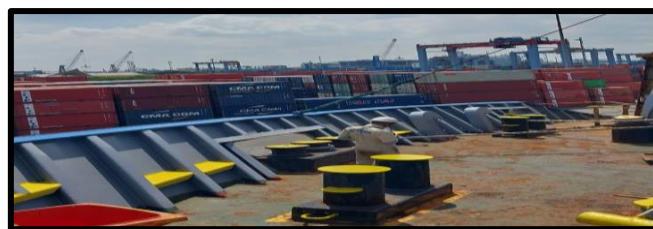
**Fig. 2. Mooring Activities**

The image shows mooring activity on the forecastle deck of the MV CTP Honor while the ship is in port. The image shows a crew member near the taut mooring line while using a mobile phone. This is considered an unsafe act because the crew member is near the rope path, which could potentially snap back if the line breaks or is suddenly released.

Furthermore, using mobile phones during mooring operations can reduce the crew's concentration on the surrounding conditions and work instructions. According to mooring safety procedures, the crew should remain focused on operational activities and avoid hazardous areas while the rope is taut.

| No | Potential Danger | Risk Rating | Category | Risk Control | Types of Control |
|---|---|---|---|---|---|
| 4 | The rope is in a taut condition | 20 | Extreme | Provide socialization of snap-back hazards and ensure crews are in a safe area. | Administrative |
