# Minimizing Potential Damage To Butterworth To Optimize Tank Cleaning Processes At MT. Bro Combo

Romeo Dominggus Philia Sitompul<sup>1\*</sup>, Dety Sutralinda<sup>2</sup>, Romanda Annas Amrullah<sup>3</sup>  
Anak Agung Istri Sri Wahyuni<sup>4</sup>

<sup>1,2,3,4</sup>Ship Operation Engineering Technology Study Program, Surabaya Maritime Polytechnic, Indonesia

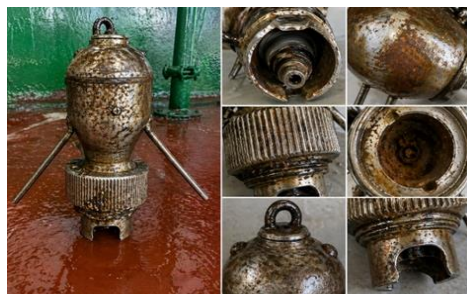
**Fig. 1 Condition of Butterworth**

Based on Figure 1, the physical condition of the butterworth on board the ship indicates that several parts of the equipment have deteriorated. This is evident from the presence of dirt adhering to the equipment's surfaces, particularly on the exterior and nozzles. Furthermore, signs of wear were also found on some units' nozzles. Further observation also revealed rust on certain parts of the butterworth, particularly on components frequently exposed to water and in humid environments.

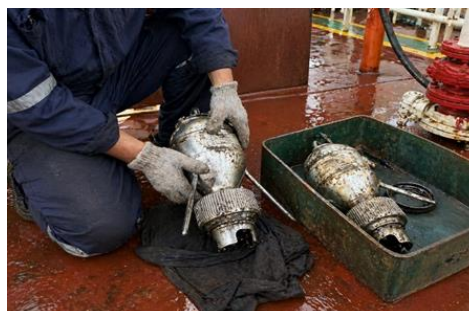
**Fig. 2 Butterworth's examination**

This condition can be seen in Figure 2, where the ship's crew conducted a direct inspection of the butterworth before the tank cleaning process. This inspection generally included checking the exterior of the equipment, the condition of the nozzle, and ensuring there was no visible physical damage. However, field observations indicated that this inspection had not been carried out comprehensively on every butterworth unit.

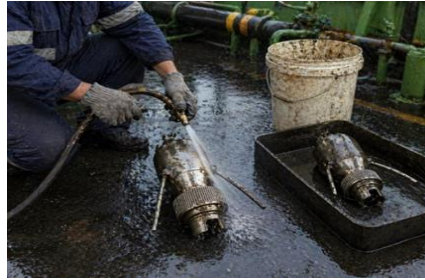
**Fig. 3 Treatment at Butterworth**

Based on observations, after the tank cleaning process was completed, maintenance activities were carried out, including butterworth cleaning. This is evident in the image, where the ship's crew cleaned the equipment using a stream of water to remove any remaining dirt. Furthermore, the exterior of the equipment was manually cleaned to maintain its cleanliness.

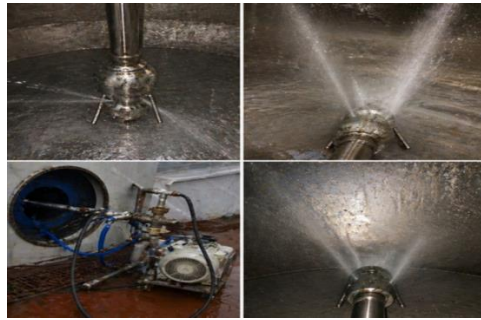
**Figure 4 Butterworth Performance and Rotation**

Based on Figure 4, the device can be seen operating inside the tank, producing water sprays in various directions. The image shows the device emitting water sprays in a specific pattern, indicating movement or rotation during the tank cleaning process. However, observations indicate that the spray direction, in some cases, does not appear to be evenly distributed across the entire tank surface. Furthermore, supporting systems such as pumps and hoses are visible, channeling water into the tank. This indicates that the device's performance is highly dependent on the water flow system used.

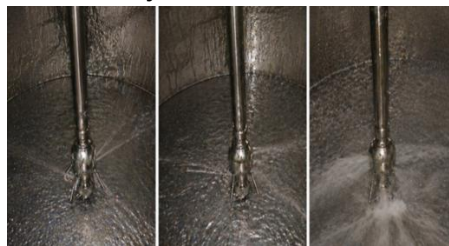
**Fig. 5 Water Pressure Instability**

Based on observations, the water pressure flowing into the Butterworth during the tank cleaning process appears to be unstable. The image shows that the resulting water jets vary in strength, with some areas appearing stronger and others weaker.

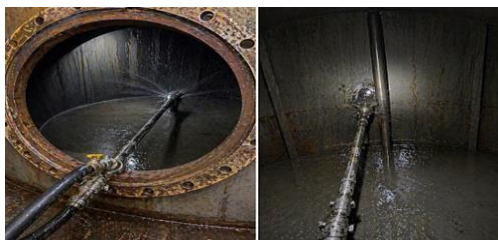
**Fig. 6 Butterworth installation**

Based on Figure 6, the Butterworth was manually installed by the ship's crew prior to the tank cleaning process. Observations indicate that the device was installed in the tank opening and connected to a pipe and hose system for water flow. However, installation accuracy was not always consistent, resulting in differences in the position of the device and the precision of its connection to the pipe during each use. This situation could potentially affect the position and direction of the Butterworth within the tank.

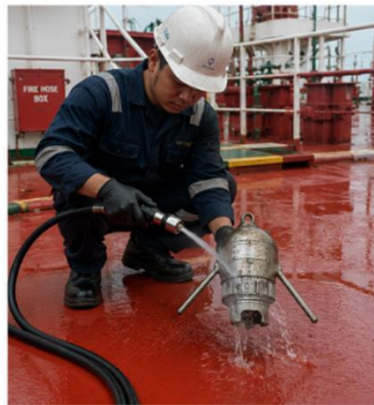
**Fig. 7 Butterworth Nozzle Cleaning Activity**

Based on Figure 7, the ship's crew cleaned the Butterworth nozzle after the tank cleaning process. Cleaning with fresh water removes oil residue, scale, and dirt adhering to the equipment. This routine maintenance activity is performed to maintain the cleanliness of the nozzle, which serves as the main channel for high-pressure water and to prevent deposits that could impair the Butterworth's performance during subsequent use.

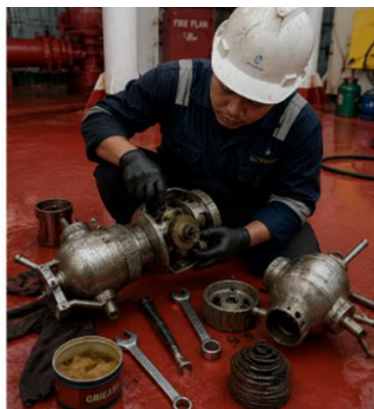
**Fig. 8 Butterworth Maintenance Activities**

Based on Figure 8, the ship's crew performed maintenance on the Butterworth by dismantling several key components for inspection. The inspection included checking the condition of the gears, bearings, nozzles, and other components involved in the tool's rotation mechanism. Furthermore, moving parts were greased to reduce friction and maintain smooth rotation. This maintenance is performed periodically to ensure the Butterworth continues to function optimally during the tank cleaning process.
