# Corrosion Rate Analysis of An Excavator Bucket (A Case Study at the Heavy Equipment Workshop Unit of the Public Works and Spatial Planning Agency (PUPR) of Bengkalis Regency)

<sup>1,2,3</sup>Department of Mechanical Engineering, Politeknik Negeri Bengkalis, Riau, Indonesia

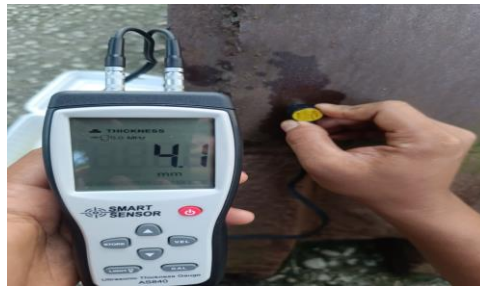
**Fig. 4.1 Initial Bucket Thickness Measurement**

The thickness measurement results showed that the excavator bucket thickness decreased from 50 mm to 41 mm during the 2023–2026 period, resulting in a 9 mm reduction in thickness, equivalent to approximately 18% of the original thickness. This reduction occurred gradually each year, indicating that the material degradation progressed continuously due to prolonged exposure to the operating environment and abrasion caused by contact with excavated materials.

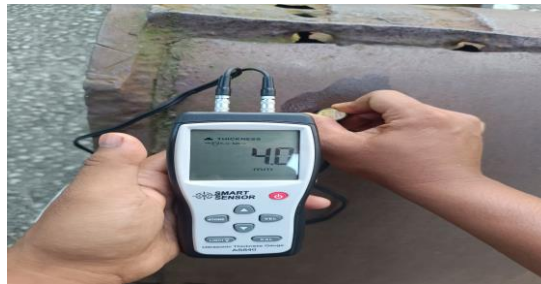
**Fig. 4.2 Bucket Reduction Thickness Measurement Results**

During the research period, follow-up thickness measurements showed that the bucket thickness decreased from 41 mm to 40 mm, indicating an additional 1 mm reduction in material thickness. Based on visual observations, the predominant type of corrosion identified was uniform corrosion, characterised by the formation of rust over nearly the entire surface of the bucket, resulting in gradual material thinning.

The calculated research parameters showed that the excavator bucket had a surface area of 14,712 cm<sup>2</sup>, a volume of 99,360 cm<sup>3</sup>, a material density of 8.05 g/cm<sup>3</sup>, and a mass loss of approximately 106,588.44 g. Furthermore, the volume of material lost due to corrosion was calculated to be 13,240.8 cm<sup>3</sup>, with a total operational exposure time of 6,300 hours.

Based on calculations using the weight loss method, the material thinning rate was determined to be 3 mm/year, while the corrosion rate was calculated at 12.50 mm/year. These results indicate that the excavator bucket experienced a relatively high rate of corrosion, requiring special attention to maintenance in order to prevent more severe damage and extend the service life of the component.

As part of corrosion control efforts, it is recommended that the bucket thickness be inspected regularly using an Ultrasonic Thickness Gauge (UTG), that the bucket be thoroughly cleaned after each operation, and that anti-corrosion coatings be applied periodically. Furthermore, buckets that have reached or exceeded the minimum allowable thickness should be repaired or replaced immediately to ensure the safety and reliability of heavy equipment. Future studies are also encouraged to expand this research by comparing different bucket materials, evaluating various anti-corrosion coating systems, and applying alternative corrosion testing methods in order to obtain more comprehensive results regarding corrosion prevention and control.
