# Analysis of The Causes of Crankshaft Failure In The Komatsu Egs 1200 Diesel Engine at Pt. Pltd Bengkalis

Hardi<sup>1\*</sup>, Ibnu Hajar<sup>2</sup>

<sup>1,2</sup>Program Studi Sarjana Terapan Teknik Mesin Produksi dan Perawatan,  
Politeknik Negri Bengkalis, Riau 28714, Indonesia.

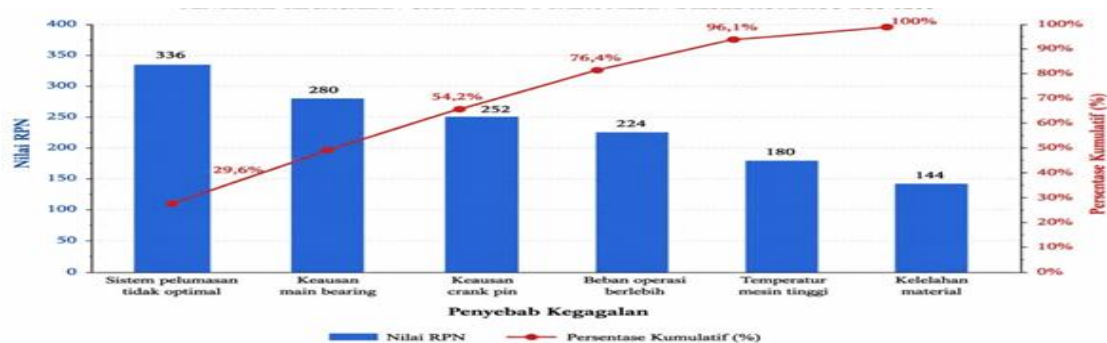
**Fig. 2. Pareto Diagram of Crankshaft Failure Causes**

The Pareto diagram was used to determine the priority of corrective actions based on the Risk Priority Number (RPN) values obtained from the Failure Mode and Effects Analysis (FMEA). A higher RPN value indicates a higher failure risk level, requiring more immediate corrective actions. The analysis results showed that crankshaft cracking had the highest RPN value of 252, followed by crankshaft fracture with an RPN value of 225, crank pin wear with an RPN value of 200, main journal wear with an RPN value of 192, and crankshaft overheating with an RPN value of 140. The high RPN values associated with crankshaft cracking and fracture indicate that these two failure modes represent the highest priorities because they can lead to complete engine shutdown and significant operational downtime. Meanwhile, crank pin and main journal wear are primarily caused by inadequate lubrication conditions, which accelerate friction and surface degradation between the rotating components. Based on the Pareto analysis, preventive maintenance activities should be prioritized through regular inspection of the lubrication system, evaluation of bearing conditions, measurement of journal wear, and monitoring of operating temperatures. These actions are expected to reduce the risk of crankshaft failure and improve the operational reliability of the Komatsu EGS 1200 diesel engine.

The FMEA analysis results indicated that the main bearing and connecting rod bearing were the components with the highest failure risk levels based on the Risk Priority Number (RPN) values, making them the primary focus in the maintenance program. The Pareto analysis revealed that the majority of potential failures were concentrated in several dominant failure modes, while the Fishbone analysis identified that human factors, machine conditions, maintenance methods, material properties, measurement systems, and environmental factors contributed collectively to the occurrence of damage. Therefore, the implementation of a scheduled preventive maintenance program, including monitoring of lubricating oil pressure and quality, inspection of bearing and crankshaft conditions, monitoring of operating temperature and engine load, as well as periodic component alignment checks, is highly required to improve engine reliability, extend the service life of the crankshaft, and minimize the risk of downtime in the power generation system.
